**Flood Control Project Maintenance  
Levee Inspections**

**Maintenance Issue Types Only, Levee Inspection Report By Mile - Fall 2018**

**Sutter Maintenance Yard East Levee Sutter Bypass**

Waterway	Bank	Unit Miles	Inspection Start/End	Inspector
Unit No. 01 Sutter Bypass Levee	Left	21.68	10/03/2018 10/03/2018	Bob Duffey

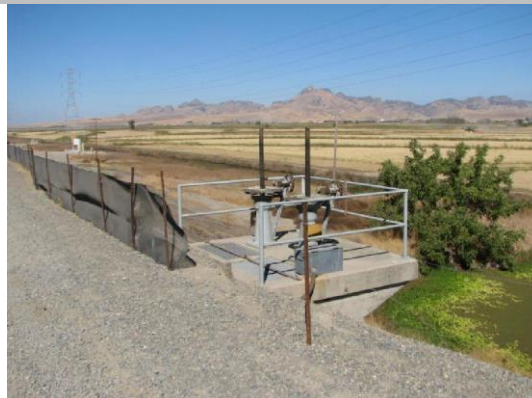
Photo 1 of 3 : UCIP\_FA\_2018\_51566\_64815.jpg

FS\_ID:51566  
DS\_ID:16880  
EP\_NO: N/A  
Repair Type: No Action Needed  
Crossing Status: Found  
UCIP Comments: 4/11/2017 Not abandoned. good condition. (DWR Sutter Yard- AFreitag)10/10/2016 NOT ABANDONED. The old pumping plant was removed but the culverts are still used as a gravity drain to regulate the water level in the LS ditch.(DWR Sutter Yard - afreitag)4/18/2016 Crossing is in good condition. The culvert is not abandoned and is used as gravity drain for the LS ditch into the bypass channel.5/7/2015 Concrete culverts are still being used as gravity drains for the LS ditch.11/12/2014 Same as last inspection.5/13/2014 Same as last inspection.10/30/2103 Same as last inspection.5/22/2013 Concrete culvert is being used as gravity drain for LS ditch.10/8/2012 Flap gates left in open position. Unable to determine type of abandonment for concrete culverts. Contact inspector to determine type of abandonment.

Slide gates on LS shoulder.

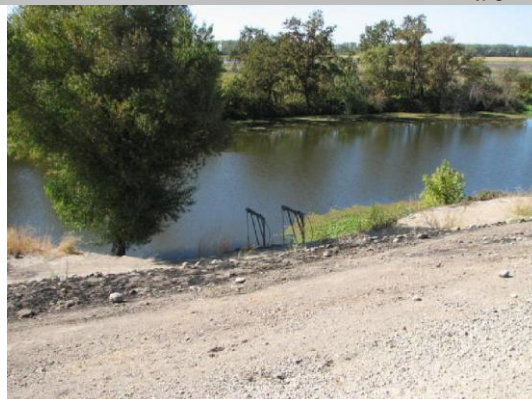
Photo 2 of 3 : UCIP\_FA\_2018\_51566\_64814.jpg

Flap gates on WS toe.

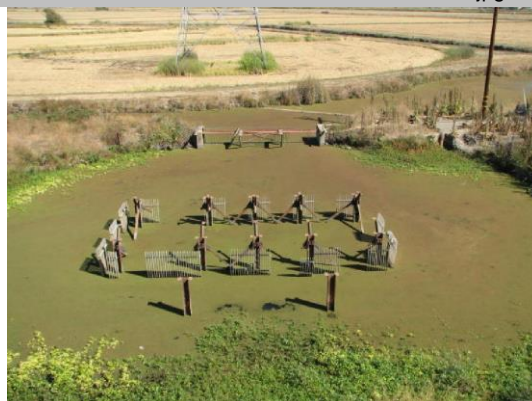
Photo 3 of 3 : UCIP\_FA\_2018\_51566\_64813.jpg

UCIP Comments: 4/11/2017 Not abandoned. good condition. (DWR Sutter Yard- AFreitag)10/10/2016 NOT ABANDONED. The old pumping plant was removed but the culverts are still used as a gravity drain to regulate the water level in the LS ditch.(DWR Sutter Yard - afreitag)4/18/2016 Crossing is in good condition. The culvert is not abandoned and is used as gravity drain for the LS ditch into the bypass channel.5/7/2015 Concrete culverts are still being used as gravity drains for the LS ditch.11/12/2014 Same as last inspection.5/13/2014 Same as last inspection.10/30/2103 Same as last inspection.5/22/2013 Concrete culvert is being used as gravity drain for LS ditch.10/8/2012 Flap gates left in open position. Unable to determine type of abandonment for concrete culverts. Contact inspector to determine type of abandonment.

Abandoned pump house and sump on LS toe.

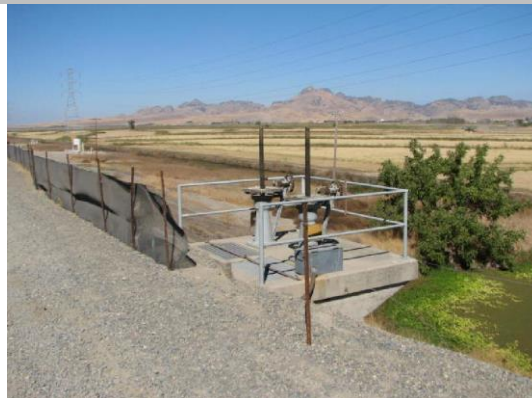
Photo 1 of 3 : UCIP\_FA\_2018\_51567\_64819.jpg

FS\_ID:51567  
DS\_ID:16895  
EP\_NO: N/A  
Repair Type: No Action Needed  
Crossing Status: Found  
UCIP Comments: 4/11/2017 Not abandoned. Good condition. (DWR Sutter Yard- AFreitag)10/10/2016 NOT ABANDONED. The old pumping plant was removed but the culverts are still used as a gravity drain to regulate the water level in the LS ditch.(DWR Sutter Yard - afreitag)4/18/2016 Crossing is in good condition. The culvert is not abandoned and is used as gravity drain for the LS ditch into the bypass channel.5/7/2015 Concrete culverst still being used as gravity drains for LS ditch.11/12/2014 Same as last inspection.5/13/2014 Same as last inspection.10/30/2103 Same as last inspection.5/22/2013 Concrete culvert is being used as gravity drain for LS ditch.10/8/2012 Flap gates in open position. Need to determine type of abandonment. Contact inspector to determine abandonment.  
FIELD\_STRUCT\_DESC: \*ABANDONED\* [Pumping Plant No. 3] 2 of 2: 48-inch by 72-inch reinforced concrete drainage culvert through the levee, 30 feet below the crown. Slide gate in concrete well on the landside (LS) shoulder. Wood flap gate and concrete headwall on the waterside (WS) end. Abandoned State pumping plant on the LS.

Slide gate valves on LS shoulder.

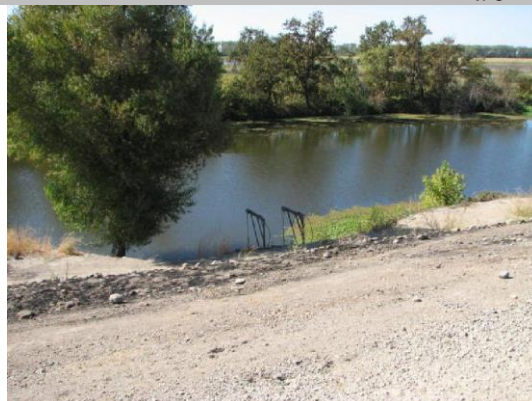
Photo 2 of 3 : UCIP\_FA\_2018\_51567\_64818.jpg

Flap gates on WS toe.

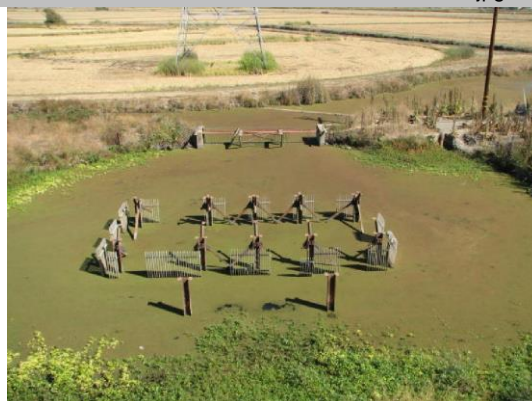
Photo 3 of 3 : UCIP\_FA\_2018\_51567\_64817.jpg

Abandoned pump house and sump on LS toe.

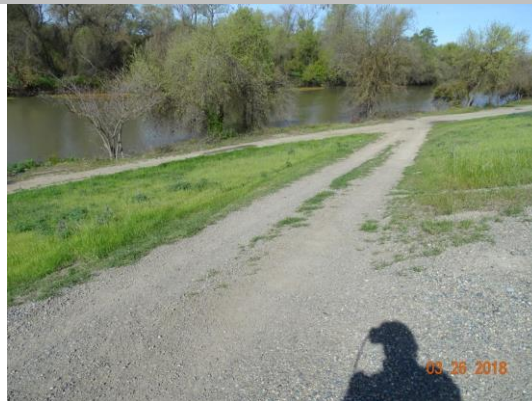
Photo 1 of 1 : FA\_2018\_ST0002\_450\_45\_20180905\_00012.jpg

LM Start	5.19	Rating **	M	Issue No.	45
LM End	5.19	Issue Type +	Ma	Location *	WS
Category	Earthen Levee			GPS Latitude/Longitude	
				Start	End
Item	Slope Stability			39.103368 °	39.103368 °
				-121.758760 °	-121.758760 °
DWR ID	DWR_ST0002_01_s_2018_45				
Comment Code					
S3 : Repair the levee slope damaged by vehicle traffic and prevent access where possible.					
Inspector Comment					
Repair the slope damaged by vehicle traffic.

View of the vehicle traffic along the waterside slope.

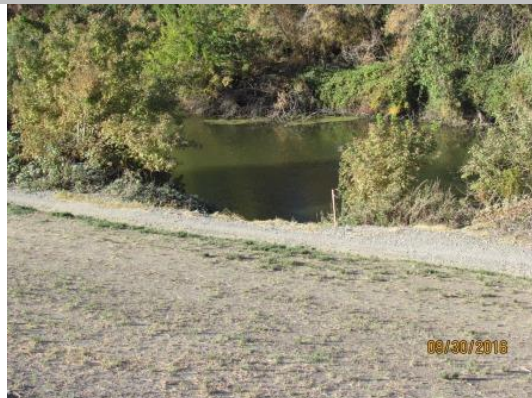
Photo 1 of 1 : FA\_2018\_ST0002\_450\_34\_20180905\_00007.jpg

LM Start	7.83	Rating **	A/W	Issue No.	34
LM End	7.83	Issue Type +	Ma	Location *	WS
Category	Earthen Levee			GPS Latitude/Longitude	
				Start	End
Item	Erosion / Bank Caving			39.067299 °	39.067299 °
				-121.742851 °	-121.742851 °
DWR ID	DWR_ST0002_01_f_2016_34				
Comment Code					
E1 : Note and monitor erosion site.					
Inspector Comment

View of the erosion along the waterside toe.

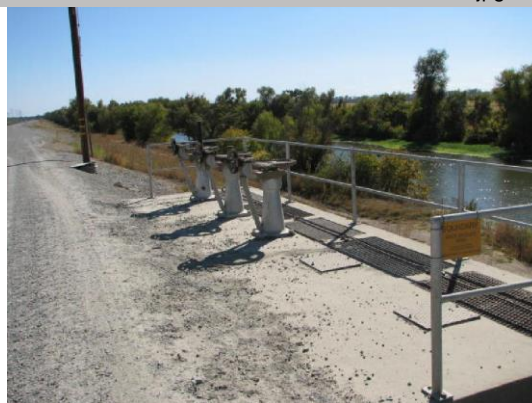
Photo 1 of 3 : UCIP\_FA\_2018\_51595\_65251.jpg

Comment Code						
Inspector Comment						
FS_ID:51595 DS_ID:16871 EP_NO: N/A Repair Type: Non-Urgent Crossing Status: Found UCIP Comments: 4/11/2017 Aabandoned.10/10/2016 Abandoned crossing.4/18/2016 Abandoned crossing but no noticeable issues seen with it.5/7/2015 Abandoned crossing but no noticebale issues with it.11/12/2014 Same as last inspection.5/13/2014 Same as last inspection.10/30/2013 Same as last inspection.5/22/2013 Same as last inspection.10/8/2012 Need to determine type of abandonment. FIELD_STRUCT_DESC: *ABANDONED* [Pumping Plant No. 2] 1 of 5: 48-inch by 72-inch reinforced concrete drainage culvert through the levee, 31.5 feet below the crown. Wood flap gate and concrete headwall on the waterside (WS) end. Wooden steps on the landside (LS) slope. Concrete steps on the WS end. [Additional Reference(s): DWR Levee Log, 2005. USACE Sacramento O&M Manual 315, May 1953 (Station 582+19)]. FS Date: 4/13/2017 2:16:54 PM

Slide gates on WS shoulder

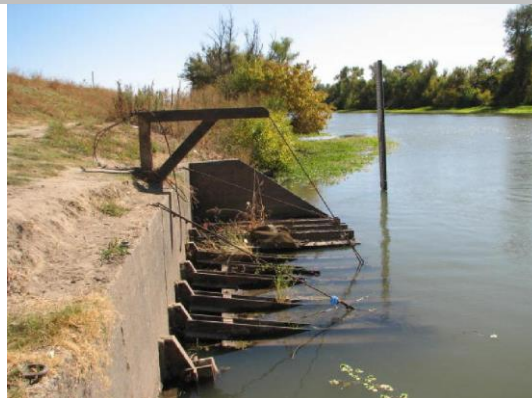
Photo 2 of 3 : UCIP\_FA\_2018\_51595\_65250.jpg

Flap gates on WS toe.

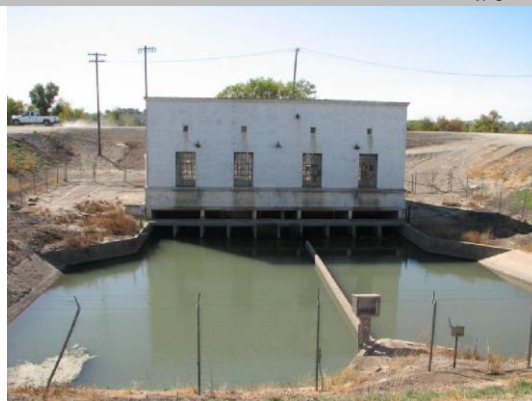
Photo 3 of 3 : UCIP\_FA\_2018\_51595\_65249.jpg

Pumphouse/intake structure on LS toe.

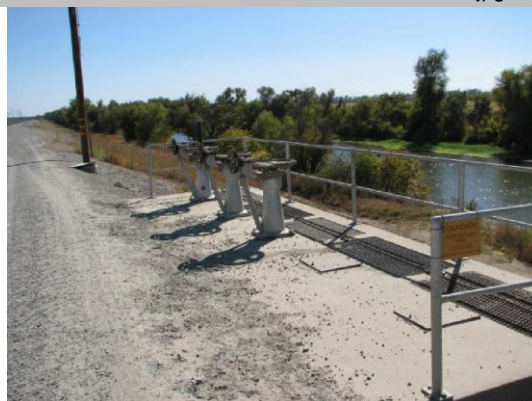
Photo 1 of 3 : UCIP\_FA\_2018\_51596\_65254.jpg

Comment Code					
Inspector Comment					
FS_ID:51596 DS_ID:16906 EP_NO: N/A Repair Type: Non-Urgent Crossing Status: Found UCIP Comments: 4/11/2017 Abandoned.10/10/2016 Crossing appears to be in good condition. (DWR Sutter Yard - afreitag)4/18/2016 Abandoned crossing but no noticeable issues seen with it.5/7/2015 Abandoned crossing but no noticeable issues to report.11/12/2014 Same as last inspection.5/13/2014 Same as last inspection.10/30/2013 Same as last inspection.5/22/2013 Same as last inspection.10/8/2012 Determine type of abandonment. FIELD_STRUCT_DESC: *ABANDONED* [Pumping Plant No. 2] 2 of 5: 48-inch by 72-inch reinforced concrete drainage culvert through the levee, 31.5 feet below the crown. Wood flap gate and concrete headwall on the waterside (WS) end. Wooden steps on the landside (LS) slope. Concrete steps on the WS end. [Additional Reference(s): DWR Levee Log, 2005. USACE Sacramento O&M Manual 315, May 1953 (Station 582+19)]. FS Date: 4/13/2017 2:17:39 PM

Slide gates on WS shoulder.

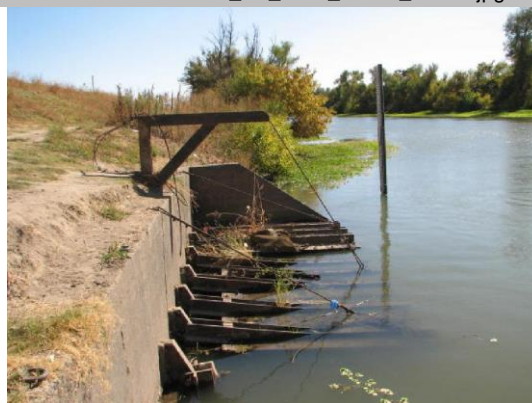
Photo 2 of 3 : UCIP\_FA\_2018\_51596\_65253.jpg

Flap gates on WS toe.

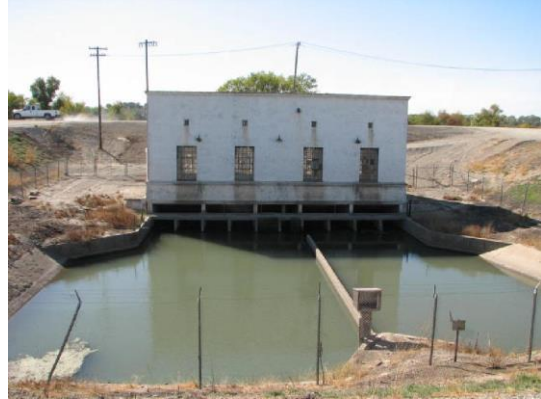
Photo 3 of 3 : UCIP\_FA\_2018\_51596\_65252.jpg

Pumping plant on LS toe.

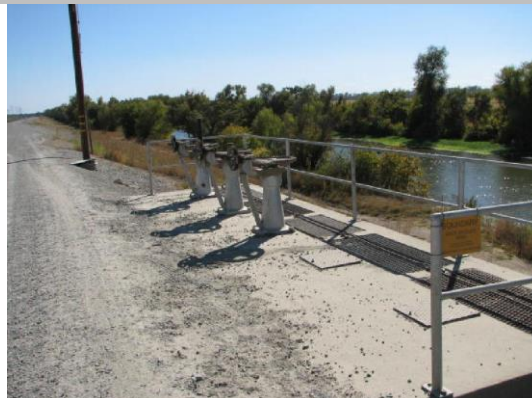
Photo 1 of 3 : UCIP\_FA\_2018\_51597\_65257.jpg

FS\_ID:51597  
DS\_ID:16907  
EP\_NO: N/A  
Repair Type: No Action Needed  
Crossing Status: Found  
UCIP Comments: 4/11/2017 Not abandoned. Good condition. (DWR Sutter Yard- AFreitag)10/10/2016 NOT ABANDONED. The old pumping plant was removed but the culverts are still used as a gravity drain to regulate the water level in the LS ditch.(DWR Sutter Yard - afreitag)4/18/2016 Crossing is in good condition. The culvert is not abandoned and is used as gravity drain for the LS ditch into the bypass channel.5/7/2015 Concrete culvert is being used as a gravity drain for LS ditch.11/12/2014 Same as last inspection.5/13/2014 Same as last inspection.10/30/2013 Same as last inspection.5/22/2013 Concrete culvert is being used as gravity drain for LS ditch.10/8/2012 Need to determine type of abandonment.  
FIELD\_STRUCT\_DESC: \*ABANDONED\* [Pumping Plant No. 2] 3 of 5: 48-inch by 72-inch reinforced concrete drainage culvert through the levee, 31.5 feet below the crown. Slide gate in concrete well on the waterside (WS) shoulder. Wood flap gate and concrete headwall on the WS end. Wooden steps on the landside (LS) slope. Concrete steps on the WS end. [Additional Reference(s): DWR Levee Log, 2005. USACE Sacramento O&M Manual 315, May 1953 (Station 582+19)].

Slide gates on WS shoulder.

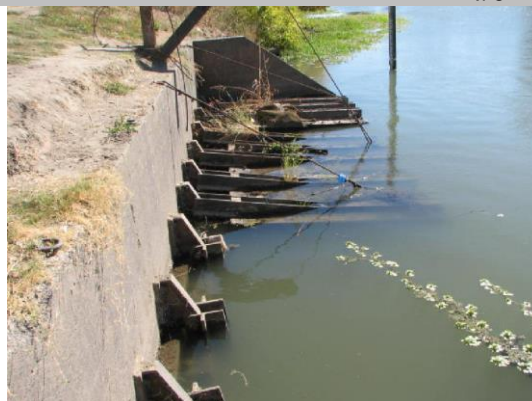
Photo 2 of 3 : UCIP\_FA\_2018\_51597\_65256.jpg

Flap gates on WS toe.

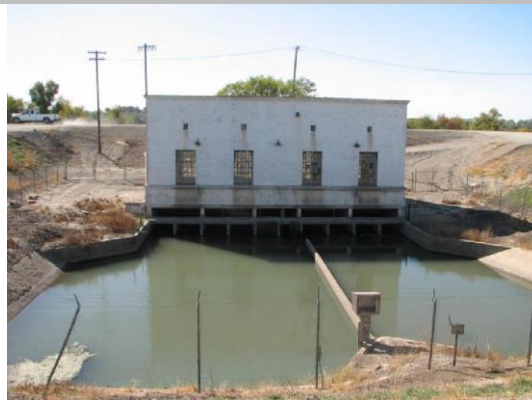
Photo 3 of 3 : UCIP\_FA\_2018\_51597\_65255.jpg

Pumphouse and intake on LS toe.

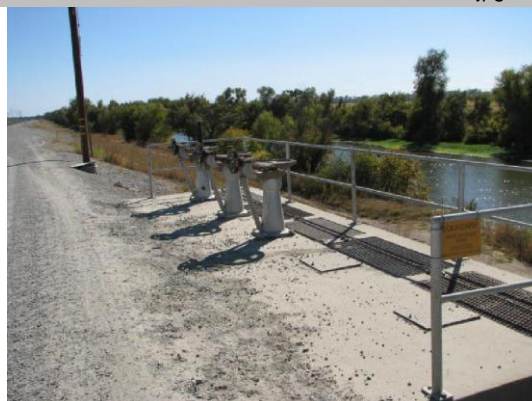
Photo 1 of 3 : UCIP\_FA\_2018\_51598\_65260.jpg

FS\_ID:51598  
DS\_ID:16908  
EP\_NO: N/A  
Repair Type: No Action Needed  
Crossing Status: Found  
UCIP Comments: 4/11/2017 Not abandoned. Good condition. (DWR Sutter Yard- AFreitag)10/10/2016 NOT ABANDONED. The old pumping plant was removed but the culverts are still used as a gravity drain to regulate the water level in the LS ditch.(DWR Sutter Yard - afreitag)4/18/2016 Crossing is in good condition. The culvert is not abandoned and is used as gravity drain for the LS ditch into the bypass channel.5/7/2015 Concrete culvert is being used as a gravity drain for LS ditch.11/12/2014 Same as last inspection.10/30/2013 Same as last inspection.10/8/2012 Need to determine type of abandonment.5/22/2013 Concrete culvert is being used as gravity drain for LS ditch.  
FIELD\_STRUCT\_DESC: \*ABANDONED\* [Pumping Plant No. 2] 4 of 5: 48-inch by 72-inch reinforced concrete drainage culvert through the levee, 31.5 feet below the crown. Slide gate in concrete well on the waterside (WS) shoulder. Wood flap gate and concrete headwall on the WS end. Wooden steps on the landside (LS) slope. Concrete steps on the WS end. [Additional Reference(s): DWR Levee Log, 2005. USACE Sacramento O&M Manual 315, May 1953 (Station 582+19)].

Slide gates on WS shoulder.

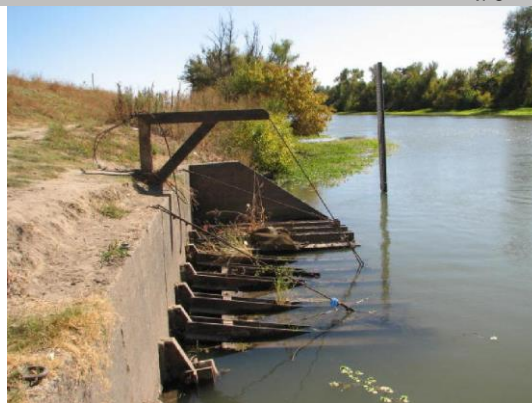
Photo 2 of 3 : UCIP\_FA\_2018\_51598\_65259.jpg

Flap gates on WS toe.

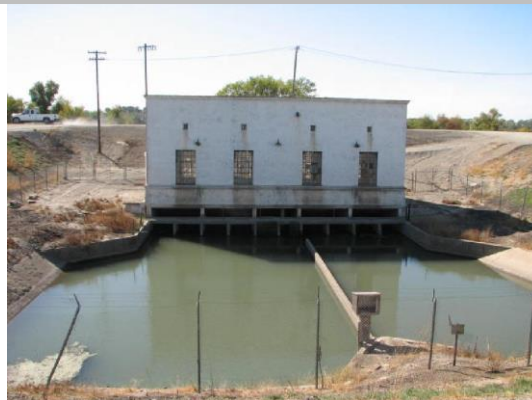
Photo 3 of 3 : UCIP\_FA\_2018\_51598\_65258.jpg

Pumphouse and intake on LS toe.

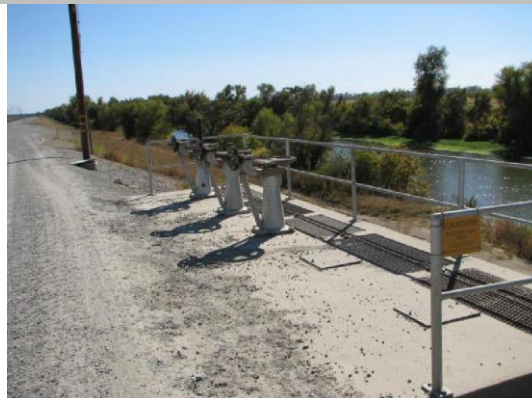
Photo 1 of 3 : UCIP\_FA\_2018\_51599\_65263.jpg

FS\_ID:51599  
DS\_ID:16909  
EP\_NO: N/A  
Repair Type: No Action Needed  
Crossing Status: Found  
UCIP Comments: 4/11/2017 Not abandoned. Good condition. (DWR Sutter Yard- AFreitag)10/10/2016 NOT ABANDONED. The old pumping plant was removed but the culverts are still used as a gravity drain to regulate the water level in the LS ditch.(DWR Sutter Yard - afreitag)4/18/2016 Crossing is in good condition. The culvert is not abandoned and is used as gravity drain for the LS ditch into the bypass channel.5/7/2015 Concrete culvert is being used as a gravity drain for LS ditch.11/12/2014 Same as last inspection.5/13/2014 Same as last inspection.10/30/2013 Same as last inspection.5/22/2013 Concrete culvert is being used as gravity drain for LS ditch.10/8/2012 Need to determine type of abandonment for pipe.  
FIELD\_STRUCT\_DESC: \*ABANDONED\* [Pumping Plant No. 2] 5 of 5: 48-inch by 72-inch reinforced concrete drainage culvert through the levee, 31.5 feet below the crown. Slide gate in concrete well on the waterside (WS) shoulder. Wood flap gate and concrete headwall on the WS end. Wooden steps on the landside (LS) slope. Concrete steps on the WS end. [Additional Reference(s): DWR Levee Log, 2005. USACE Sacramento O&M Manual 315, May 1953 (Station 582+19)].

Slide gates on WS shoulder.

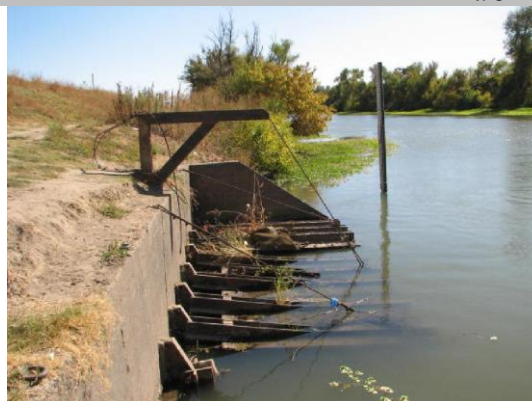
Photo 2 of 3 : UCIP\_FA\_2018\_51599\_65262.jpg

Flap gates on WS Toe.

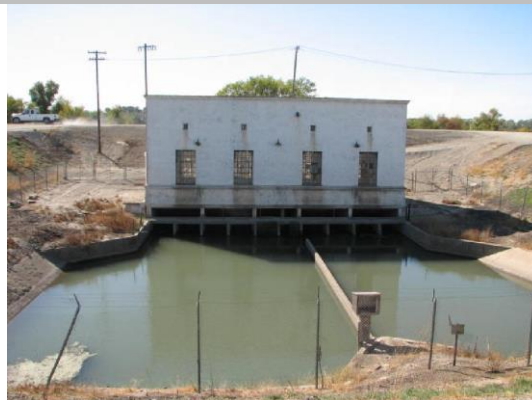
Photo 3 of 3 : UCIP\_FA\_2018\_51599\_65261.jpg

Pumphouse/intake on LS toe.

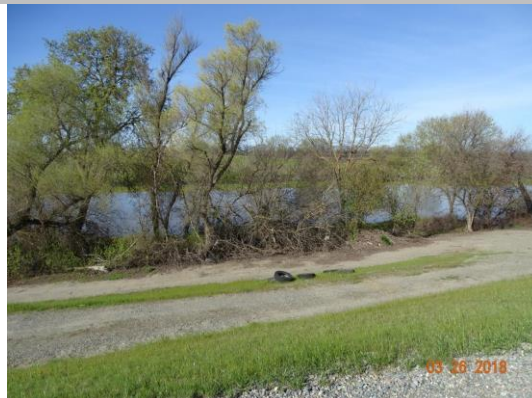
Photo 1 of 1 : FA\_2018\_ST0002\_450\_44\_20180905\_00011.jpg

View of the tires along the waterside slope and toe.

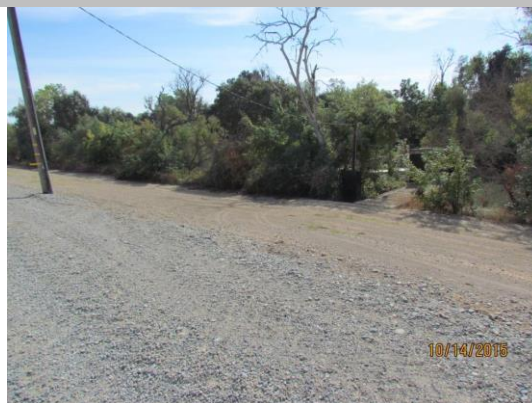
Photo 1 of 1 : FA\_2018\_ST0002\_450\_23\_20180905\_00004.jpg

LM Start	13.34	Rating **	A/W	Issue No.	23
LM End	13.34	Issue Type +	Ma	Location *	WS
Category	Earthen Levee			GPS Latitude/Longitude	
				Start	End
Item	Slope Stability			38.991857 °	38.991857 °
				-121.711555 °	-121.711555 °
DWR ID	DWR_ST0002_01_s _ 2015_23				
Comment Code					
S3 : Repair the levee slope damaged by vehicle traffic and prevent access where possible.					
Inspector Comment					
Monitor the erosion along the waterside slope.

View of the vehicle erosion along the slope.

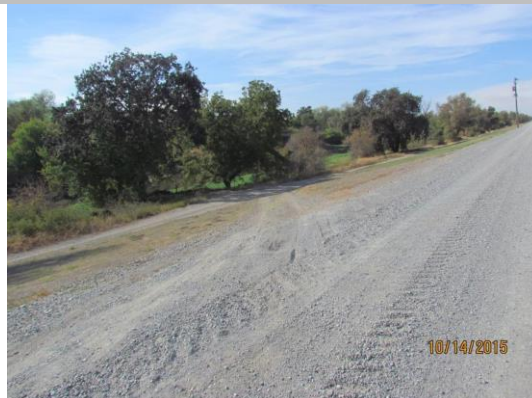
Photo 2 of 2 : FA\_2018\_ST0002\_450\_21\_20180905\_00003.jpg

LM Start	17.60	Rating **	M	Issue No.	21 (cont)	
LM End	17.60	Issue Type +	Ma	Location *	WS	
Category	Earthen Levee			GPS Latitude/Longitude		
				Start		End
Item	Slope Stability			38.949965 °		38.949965 °
				-121.653823 °		-121.653823 °
DWR ID	DWR_ST0002_01_s_2015_21					
Comment Code						
S3 : Repair the levee slope damaged by vehicle traffic and prevent access where possible.						
Inspector Comment						
Repair the vehicle erosion along the waterside slope.

View of the vehicle erosion along the waterside slope.

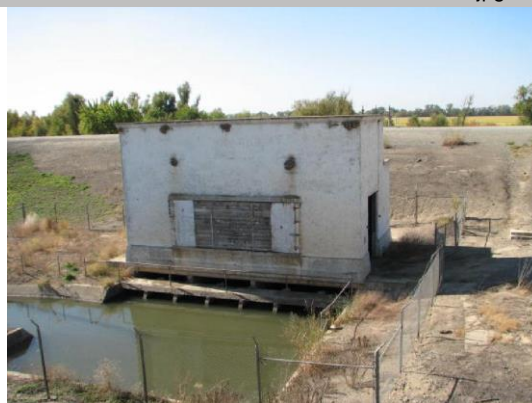
Photo 1 of 3 : UCIP\_FA\_2018\_51609\_65326.jpg

Comment Code					
Inspector Comment					
FS_ID:51609 DS_ID:16877 EP_NO: N/A Repair Type: No Action Needed Crossing Status: Found UCIP Comments: 4/11/2017 Not abandoned. Good condition. (DWR Sutter Yard - A Freitag)10/10/2016 NOT ABANDONED. The old pumping plant was abandoned but the culverts are still used as a gravity drain to regulate the water level in the LS ditch.(DWR Sutter Yard - a Freitag)4/18/2016 Crossing is in good condition. The culvert is not abandoned and is used as gravity drain for the LS ditch into the bypass channel.5/7/2015 Concrete culvert is being used as a gravity drain for LS ditch.11/12/2014 Same as last inspection.5/14/2014 Same as last inspection.10/30/2013 Same as last inspection.5/23/2013 Concrete culvert is being used as gravity drain for LS ditch.10/9/2012 Determine type of abandonment for concrete culvert. FIELD_STRUCT_DESC: [Pumping Plant No. 1] 1 of 3: 48-inch by 72-inch reinforced concrete drainage culvert through the levee, 26 feet below the crown. Slide gates in a concrete well on the waterside (WS) shoulder. Wooden flap gates and concrete headwall on the WS end. Concrete steps and staff gage reading to 53 feet on the WS slope. [Additional Reference(s): DWR Levee Log, 2005. USACE Sacramento O&M Manual 315, May 1953 (Station 141+46)]. FS Date: 4/13/2017 2:44:23 PM

Pumphouse on LS toe.

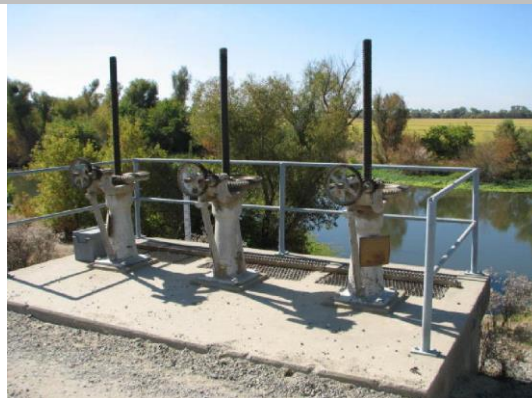
Photo 2 of 3 : UCIP\_FA\_2018\_51609\_65325.jpg

Slide gates on WS shoulder.

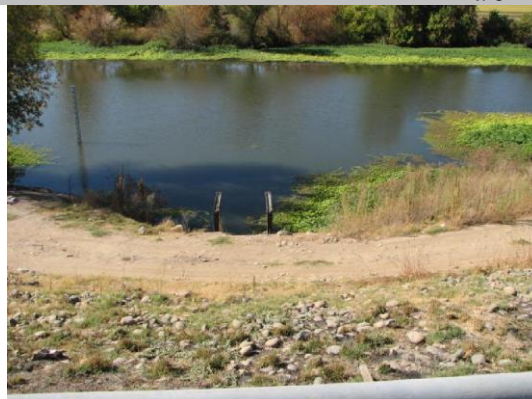
Photo 3 of 3 : UCIP\_FA\_2018\_51609\_65327.jpg

Flap gates on WS toe.

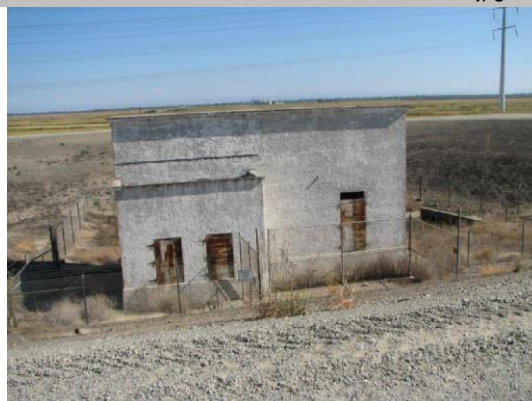
Photo 1 of 3 : UCIP\_FA\_2018\_51610\_65330.jpg

UCIP Comments: 4/11/2017 Not abandoned. Good Condition. (DWR Sutter Yard- AFreitag)10/10/2016 NOT ABANDONED. The old pumping plant was abandoned but the culverts are still used as a gravity drain to regulate the water level in the LS ditch.(DWR Sutter Yard - afreitag)4/18/2016 Crossing is in good condition. The culvert is not abandoned and is used as gravity drain for the LS ditch into the bypass channel.5/7/2015 Concrete culvert is being used as a gravity drain for LS ditch.11/12/2014 Same as last inspection.5/14/2014 Same as last inspection.10/30/2013 Same as last inspection.5/23/2013 Concrete culvert is being used as gravity drain for LS ditch.10/9/2012 Determine type of abandonment for concrete culverts.

Pumphouse on LS toe.

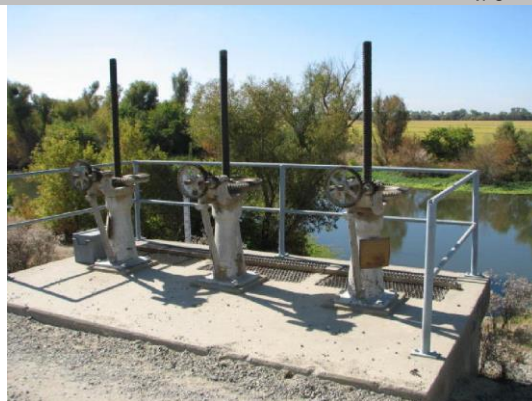
Photo 2 of 3 : UCIP\_FA\_2018\_51610\_65329.jpg

Slide gates on WS shoulder.

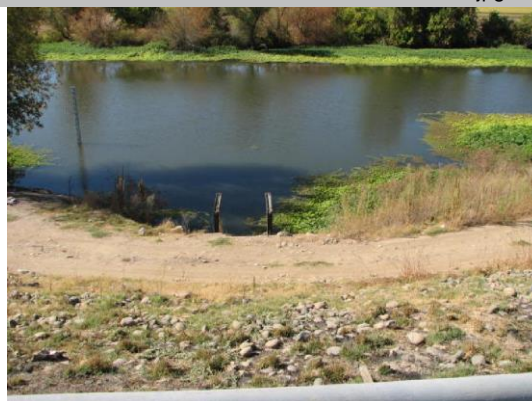
Photo 3 of 3 : UCIP\_FA\_2018\_51610\_65328.jpg

Flap gates on WS toe.

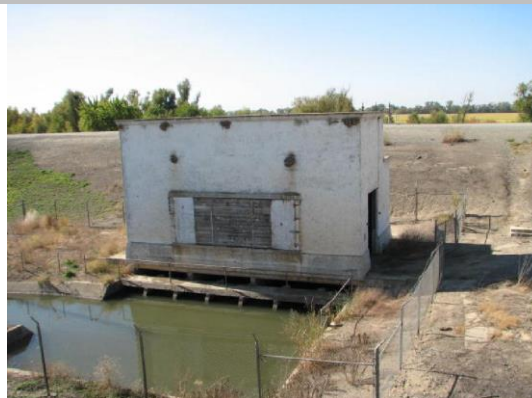
Photo 1 of 3 : UCIP\_FA\_2018\_51611\_65333.jpg

FS\_ID:51611  
DS\_ID:17028  
EP\_NO: N/A  
Repair Type: No Action Needed  
Crossing Status: Found  
UCIP Comments: 4/11/2017 Not Abandoned. Good Condition. (DWR Sutter Yard - A Freitag)10/10/2016 NOT ABANDONED. The old pumping plant was abandoned but the culverts are still used as a gravity drain to regulate the water level in the LS ditch.(DWR Sutter Yard - a Freitag)4/18/2016 Crossing is in good condition. The culvert is not abandoned and is used as gravity drain for the LS ditch into the bypass channel.5/7/2015 Concrete culvert is being used as a gravity drain for LS ditch.11/12/2014 Same as last inspection.5/14/2014 Same as last inspection.10/30/2013 Same as last inspection.5/23/2013 Concrete culvert is being used as gravity drain for LS ditch.10/9/2012 Need to determine type of abandonment for concrete culverts.  
FIELD\_STRUCT\_DESC: [Pumping Plant No. 1] 3 of 3: 48-inch by 72-inch reinforced concrete drainage culvert through the levee, 26 feet below the crown. Slide gates in a concrete well on the waterside (WS) shoulder. Wooden flap gates and concrete headwall on the WS end. Concrete steps and staff gage reading to 53 feet on the WS slope. [Additional Reference(s): DWR Levee Log, 2005. USACE Sacramento O&M Manual 315, May 1953 (Station 141+46)].

Pumphouse on LS toe.

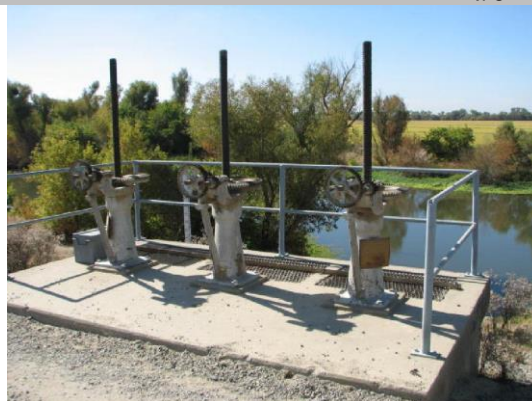
Photo 2 of 3 : UCIP\_FA\_2018\_51611\_65332.jpg

Slide gates on WS shoulder.

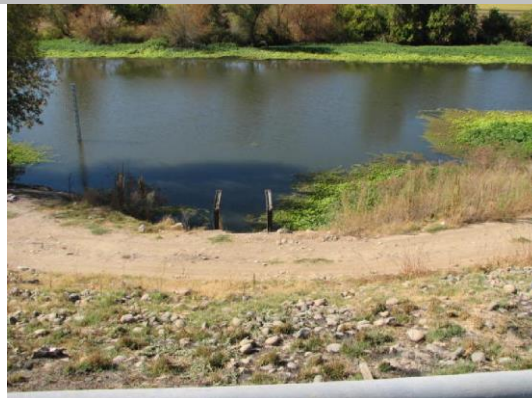
Photo 3 of 3 : UCIP\_FA\_2018\_51611\_65331.jpg

Flap gate at WS toe.

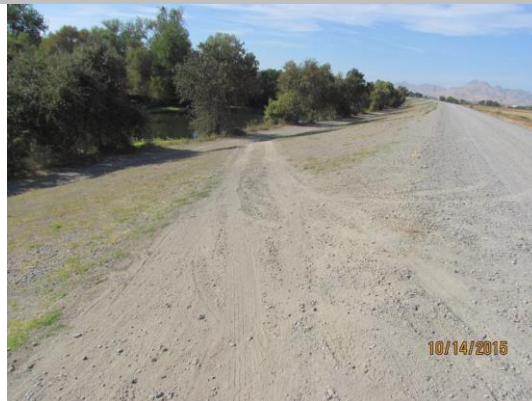
Photo 1 of 1 : FA\_2018\_ST0002\_450\_29\_20180905\_00006.jpg

LM Start	20.02	Rating **	M	Issue No.	29
LM End	20.02	Issue Type +	Ma	Location *	WS
Category	Earthen Levee			GPS Latitude/Longitude	
				Start	End
Item	Slope Stability			38.922678 °	38.922678 °
				-121.625890 °	-121.625890 °
DWR ID	DWR_ST0002_01_f_2015_29				
Comment Code					
S3 : Repair the levee slope damaged by vehicle traffic and prevent access where possible.					
Inspector Comment

View of the vehicle erosion along the waterside slope.
